NATIONAL DAM SAFETY PROGRAM. UNION LAKE DAM

**UNION LAKE DAM**

**JACKSON COUNTY, MISSOURI**

# **PHASE 1 INSPECTION REPORT NATIONAL DAM SAFETY PROGRAM**

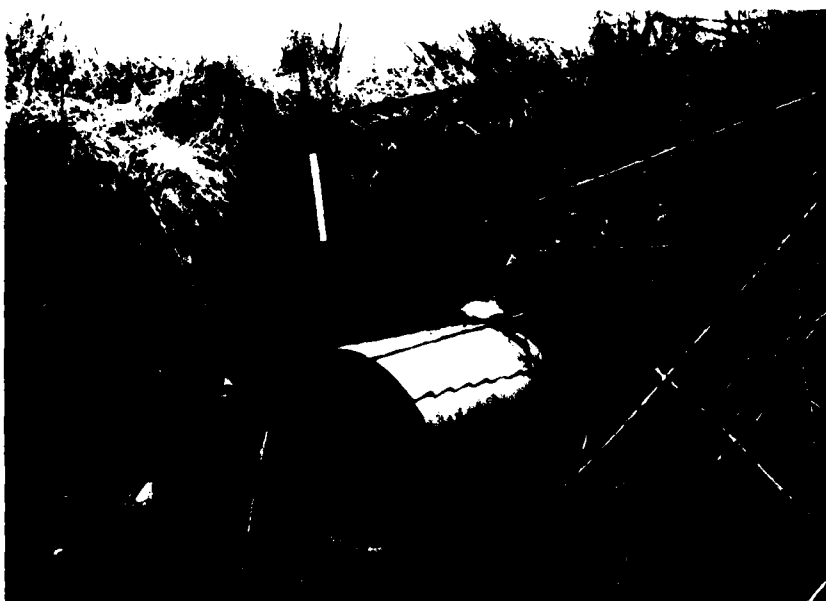
- (2) The secondary spillway conduits appear to be in less than fair condition. The lake level at the time of inspection was below their inlet elevations. The 12-inch concrete pipe spillway was essentially plugged with earth and debris and was not considered a discharge point for purposes of this report. The 16-inch corrugated metal pipe was open. The outlet ends of these pipes are located at an eroded channel at the right abutment.

PHOTO 10: OUTLET END OF CORRUGATED METAL PIPE, RIGHT END OF DAM
